BP Refinery Site, Casper, Wyoming, USA

Three Crowns Golf Course

By: Larry Peters

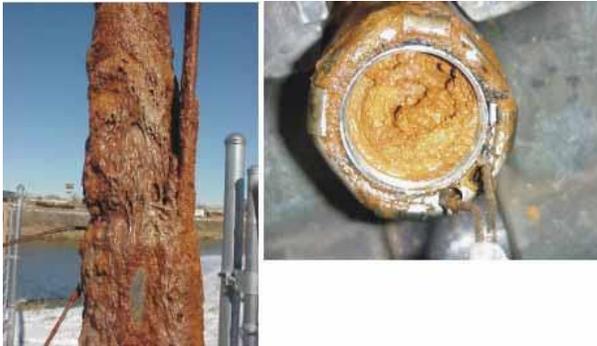
Shown at far left is a stainless steel Grundfos submersible water pump. Iron sediment bacteria cover the apparatus.

Note how the outside of the pump, intake ports on the pump, check valve and discharge line are all either covered or plugged with this buildup of iron sediment bacteria. This pump had been in service for less than one year.

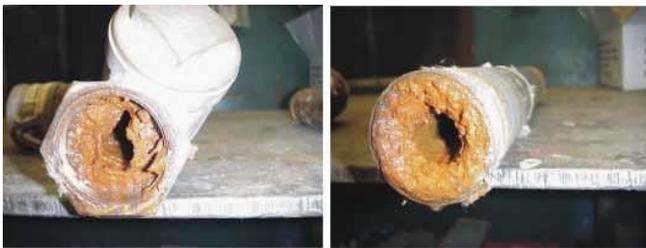
Photo at right is the 2 inch discharge end of this same water pump. It is easy to see that the flow of water was seriously restricted.

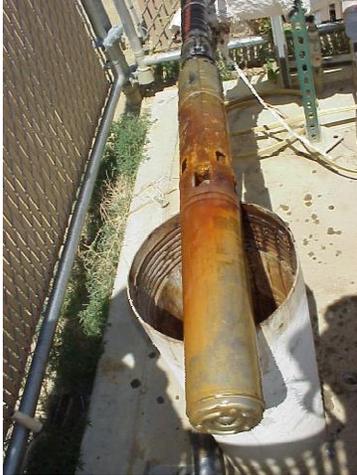
Dismantled discharge manifold located at the surface above the submersible pump.
